PASSAIC RIVER BASIN
" HOKUS CREEK, BERGEN COUNTY
NEW JERSEY

SHADOW LAKE DAM

NJ 00232

PHASE 1 INSPECTION REPORT
NATIONAL DAM SAFETY PROGRAM

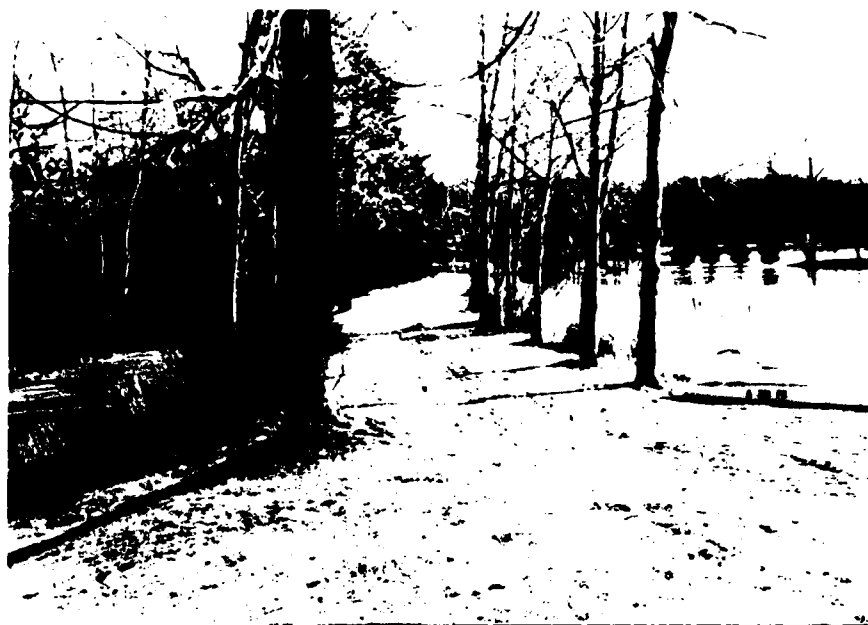
Photo 1 - View of embankment toward right edge of dam. Portion of bituminous service road, at foot of downstream slope, is visible at left. (Photo taken on February 8, 1980).

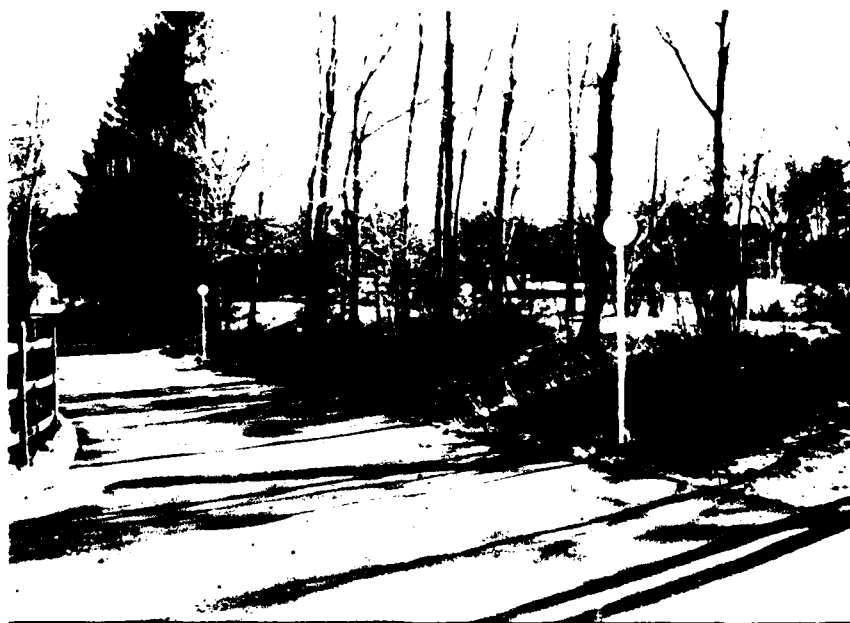
Photo 2 - View of downstream side of the embankment, toward right edge of dam, and the service road at the foot of the embankment. Swimming pool is out of photo to viewer's left. (Photo taken on February 8, 1980).

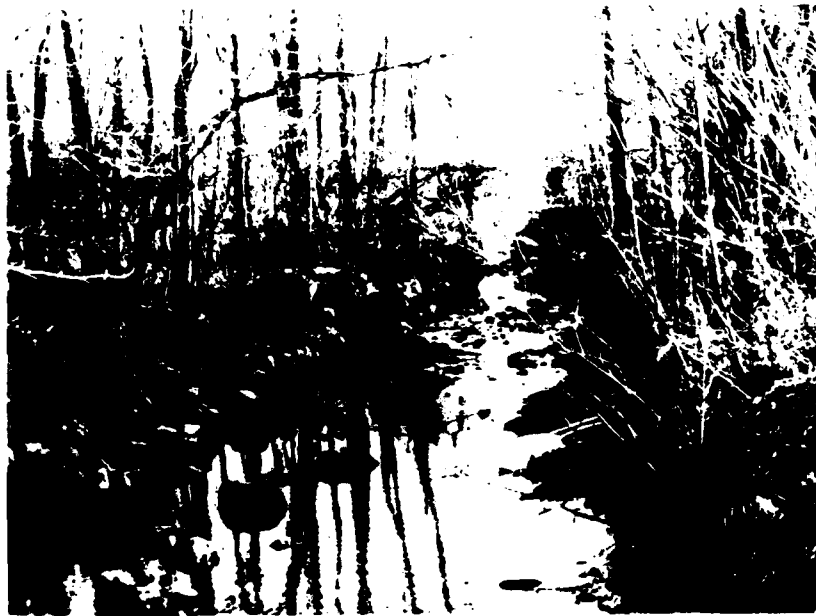
Photo 12 - View of downstream channel, from the low level outlet drain, towards the two 48-inch reinforced concrete pipes mentioned above in photo 11. (Photo taken on November 27, 1979).
